**US Army Corps
of Engineers®**

Engineering Documentation Report

Green River Lock and Dam No. 3
Contract No. W912QR-08-D-0005
Task Order No. 0008
Rochester, Kentucky

May 18, 2011

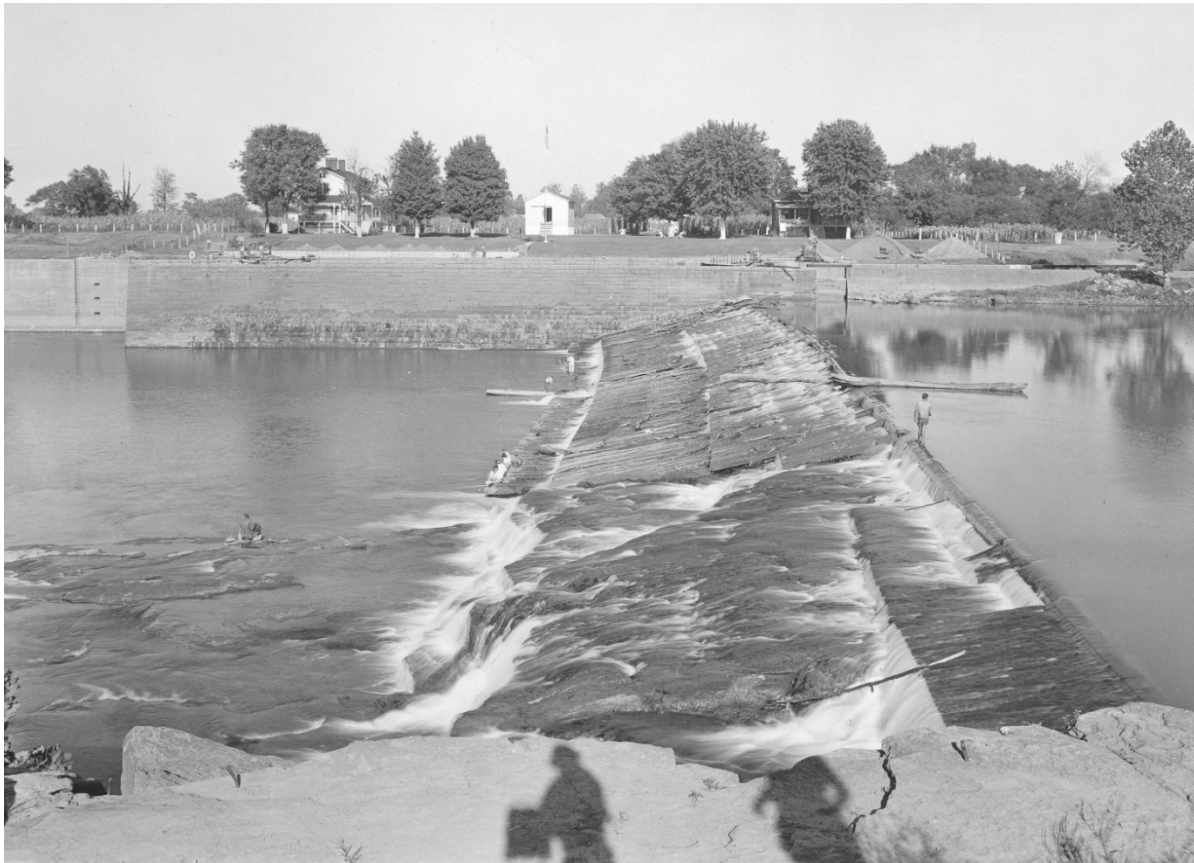
Figure 4) would indicate that for some period of time, a wooden control section was constructed across the rock shelf and the mill race, presumably to provide a consistent crest elevation over the width of the river.

**Figure 4. Photo Showing Planking Face
of Dam, Control Section, and
Rock Shelf (c. 1939)**

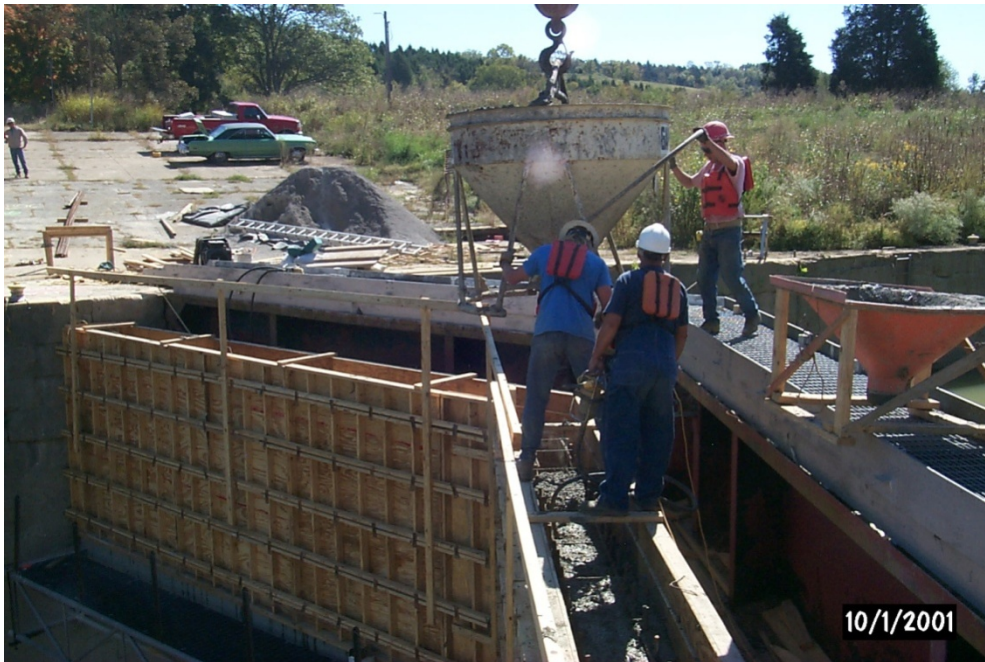
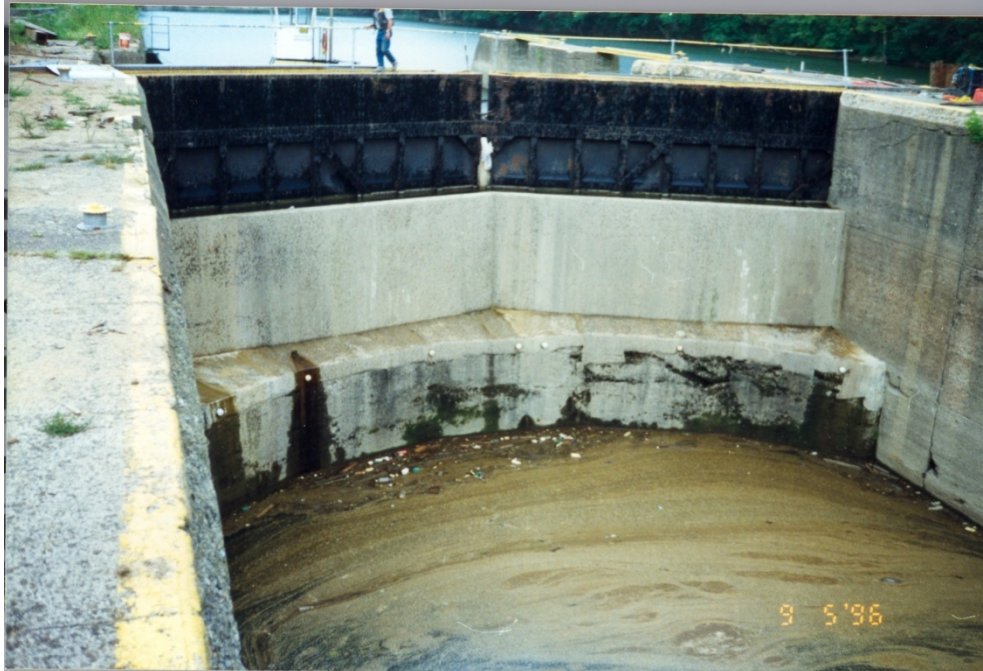
Figure 10. Examples of Concrete Bulkhead
 Wall Construction (Kentucky River
 Lock and Dam Nos. 8 (top) and 11
 (bottom))

Next, a reinforced concrete bulkhead wall (Figure 10) would be constructed on the upper sill. The wall would be keyed into the lock walls and the upper sill as shown on Sheet C-015. The top elevation of the bulkhead wall (385.4 feet) is located between the crest elevation of the dam (380.7 feet) and the lock wall elevation (390.4 feet). The lower elevation of the bulkhead wall (compared to the lock gates) would help to limit the height of sediment accumulating in the lock chamber, thus providing a deterrent to individuals attempting to access the river lock wall by walking across the sediment in the chamber. The higher elevation of the bulkhead wall (compared to the dam) would limit the frequency of flow through the lock chamber, thus limiting the potential for scour along the inside toe of the land and river lock walls. A reinforced concrete splash pad would be constructed on the portion of the upper sill downstream of the new bulkhead wall (Figure 10). The splash pad provides erosion resistance against overtopping flows.

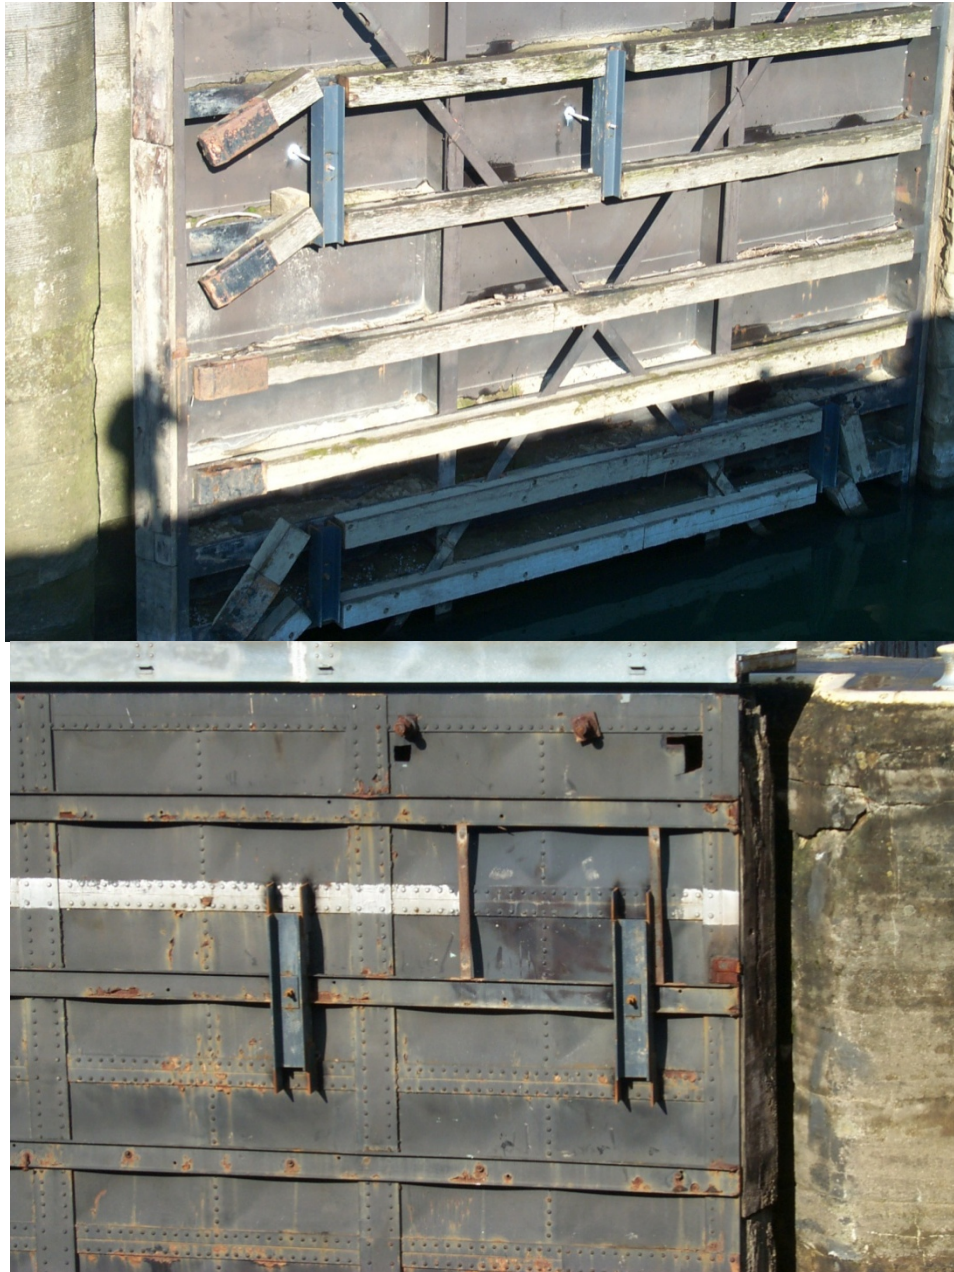
Figure 11. Example of Steel Tiebacks to Secure Gates (Kentucky River Lock and Dam Nos. 8 and 9)

After construction of the bulkhead wall, the upper gates would then be pinned in the open position by securing them to the lock walls (Sheets C-012 and C-015) using four steel tiebacks (Figure 11) which are comprised of a W-steel section, a steel plate, and an anchor rod (Sheet C-015).
